Observations of New and Reprocessed Octopus 3[®] Tissue Stabilizers and Octopus4[®] Tissue Stabilizers

The objective of this study was to evaluate new sterile and reprocessed sterile Medtronic Octopus 3[®] and Octopus 4[®] Tissue Stabilizers (see attached product PDF files). A report dated May 24, 2004 contained information and data describing the differences observed between new sterile and reprocessed sterile Medtronic Octopus 3[®] and Octopus 4[®] Tissue Stabilizers. In that report a total of four devices were assessed, one new sterile Medtronic Octopus 3[®], one new sterile Medtronic Octopus 4[®], one reprocessed sterile Medtronic Octopus 3[®] (SterilMed) and one reprocessed sterile Medtronic Octopus 4[®] (Alliance). Subsequent to that report, eight additional reprocessed Medtronic Octopus 3[®] and Octopus 4[®] Tissue Stabilizers from the same two reprocessors were examined using similar microscopic and molecular techniques. On June 7, 2004 the additional reprocessed Medtronic Octopus 3[®] and Octopus 4[®] Tissue Stabilizers were received. Results of eight of those are contained in this study for a total of twelve devices, two new sterile devices and ten reprocessed devices.

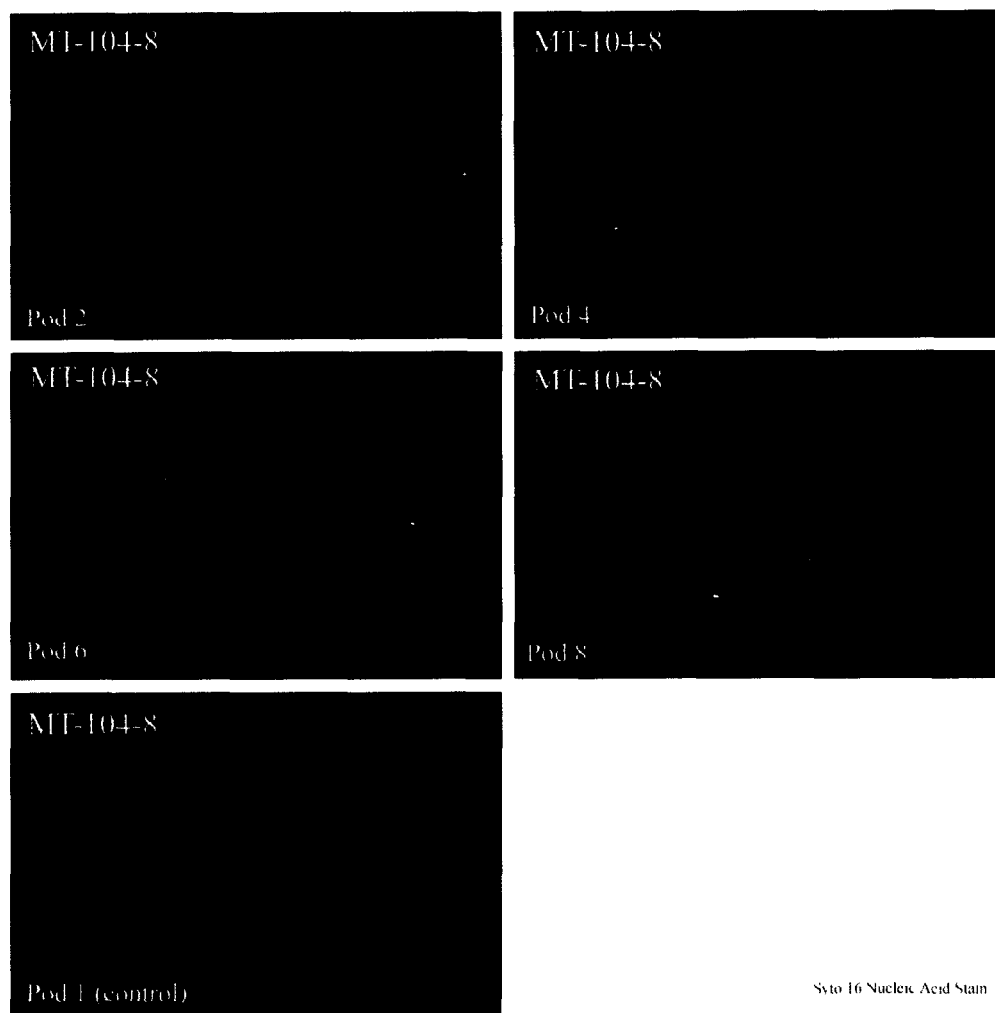
Figure 83. MT-104-8, pod #s 2, 4, 6 and 8 treated with Syto 16 nucleic acid probe. Projections (maximum intensity method) of series of optical sections collected from the laser scanning confocal microscope through the hypotube area of the pod following treatment with 1 μ M of the stain Syto 16. Bright regions indicate positive nucleic acid staining. Pod #1 is an unstained control image through the same area of the hypotube as the other images. The control image shows a low level of autofluorescence.
